INDOOR AIR QUALITY ASSESSMENT

**Joshua Hyde Public Library
306 Main St
Sturbridge, MA**

Prepared by:
Massachusetts Department of Public Health
Bureau of Environmental Health
Indoor Air Quality Program
November 2018

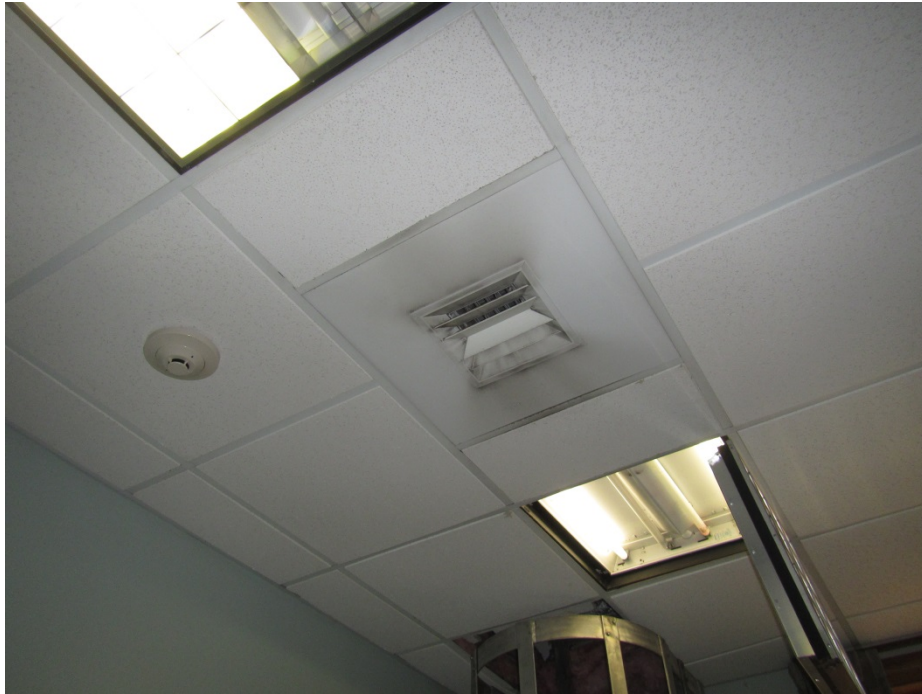
Picture 1

The JHPL main floor is served by an HVAC system located on the roof. This system heats or cools fresh air and supplies it through ducts to vents located in the ceiling (Pictures 1 through 3). Return vents are present on the walls of the main room (Picture 4). This HVAC system was installed in the 1980s. Floor-mounted vents exist in the front part of the main floor (Picture 5). To maximize air exchange, the MDPH recommends that both supply and exhaust ventilation operate continuously during periods of occupancy. In order to have proper ventilation with a mechanical supply and exhaust system, the systems must be balanced to provide an adequate amount of fresh air to the interior of a room while removing stale air from the room. It is recommended that HVAC systems be re-balanced every five years to ensure adequate air systems function (SMACNA, 1994). This HVAC system was most recently balanced in early 2018.

Supply vent in stairwell

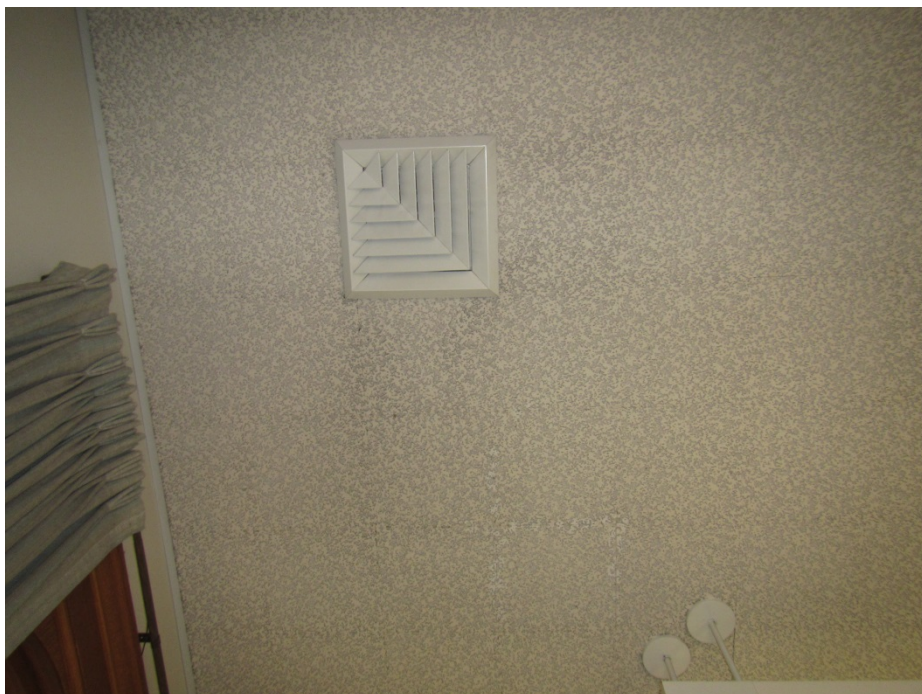
Picture 2

Supply vent in non-fiction section

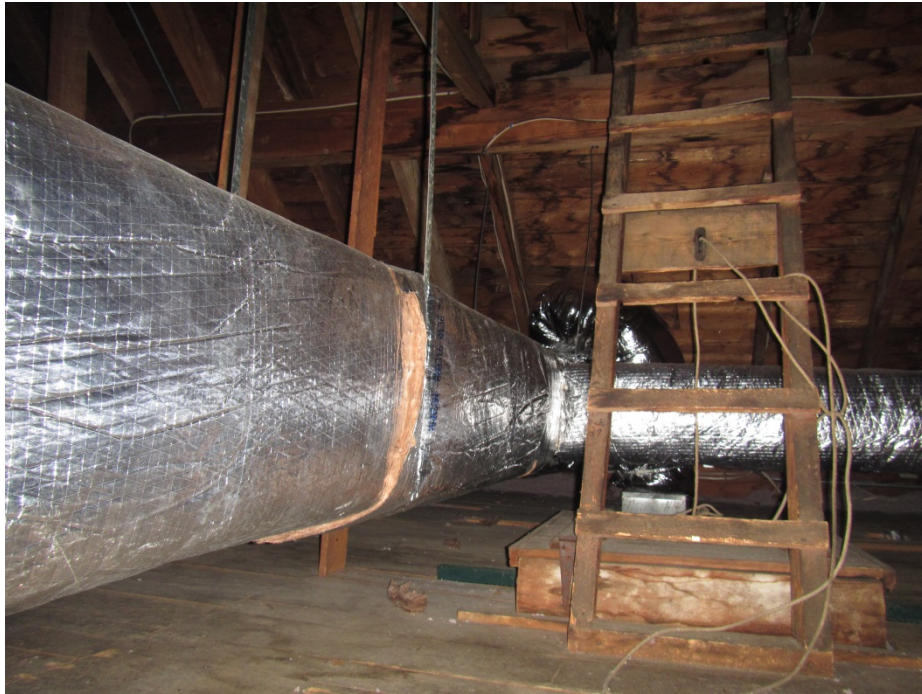
Picture 3

Ducts in attic above main floor

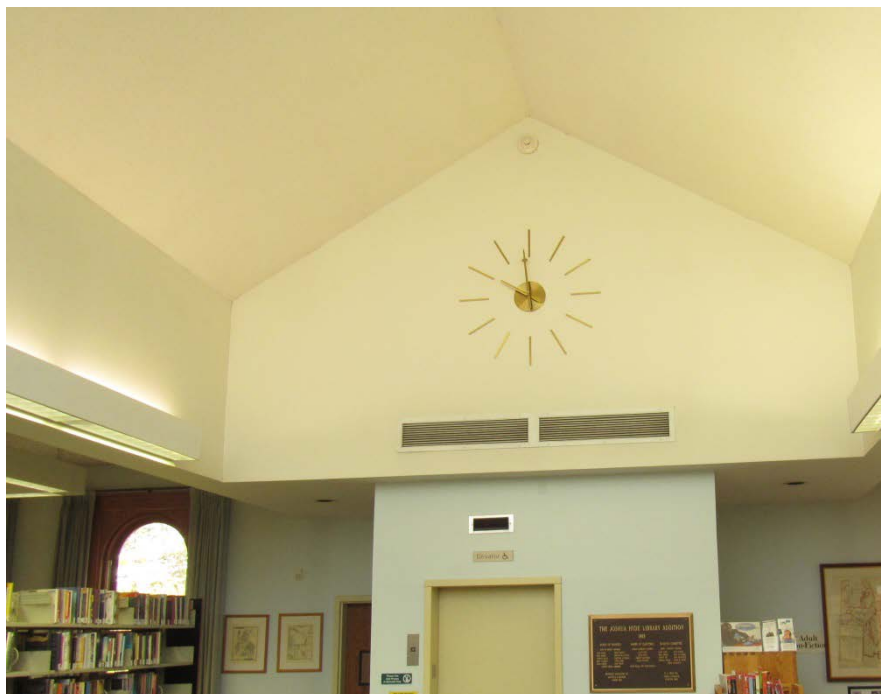
Picture 4

Return vents

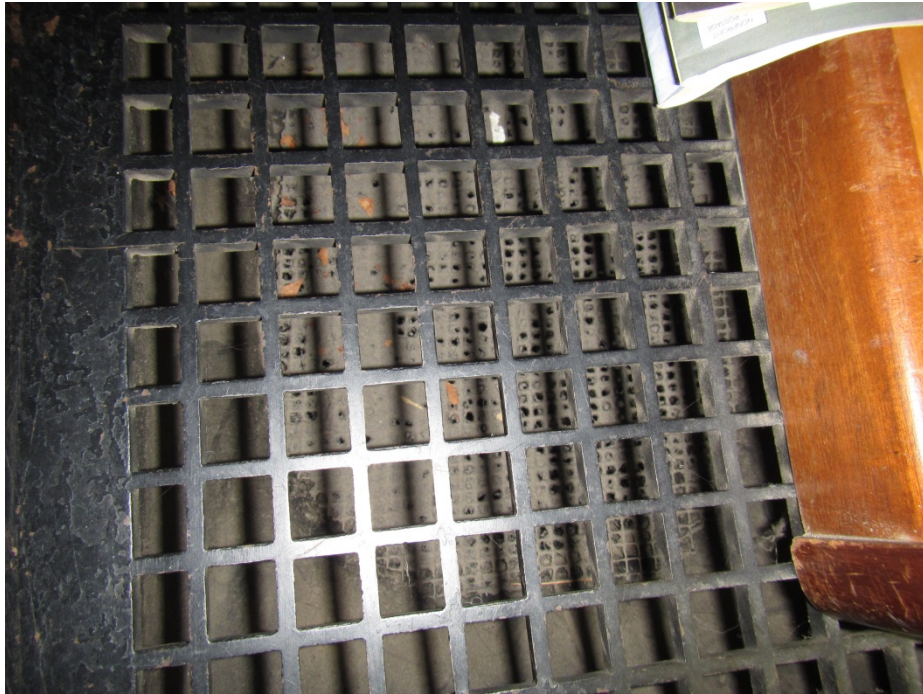
Picture 5

Dust in floor vent in Mystery section

18. Clean personal fans, supply and exhaust vents regularly to prevent aerosolization of debris.
19. Clean carpeting, upholstered items, and curtains regularly in accordance with IICRC recommendations (IICRC, 2012).

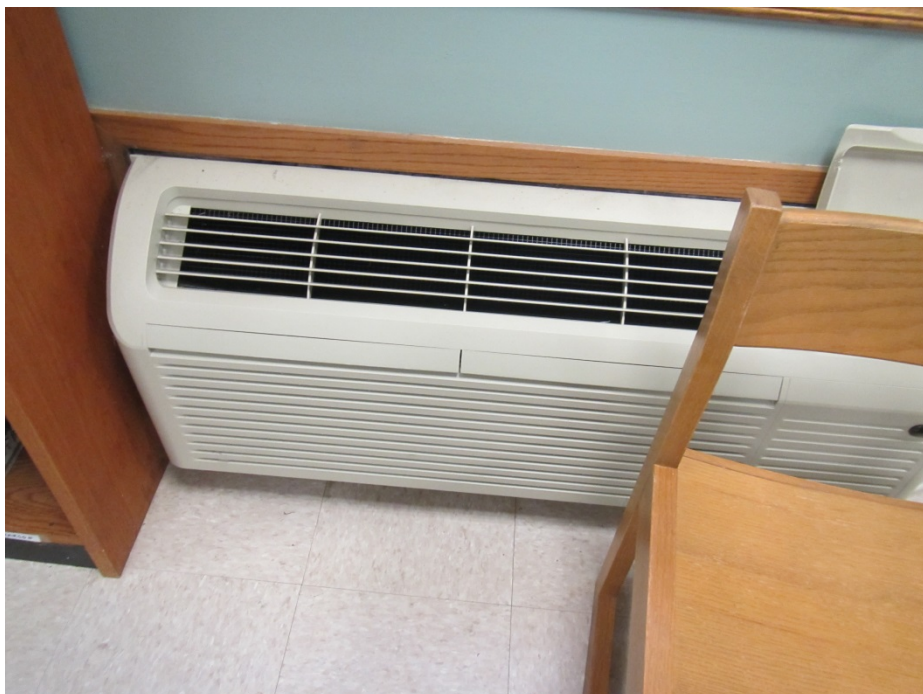
Picture 6

On the lower level, unit ventilators supply tempered air from vents in the side of the building (Pictures 6 and 7). Note that one of the fresh air intake vents is obstructed by plants.

Unit ventilator in lower level

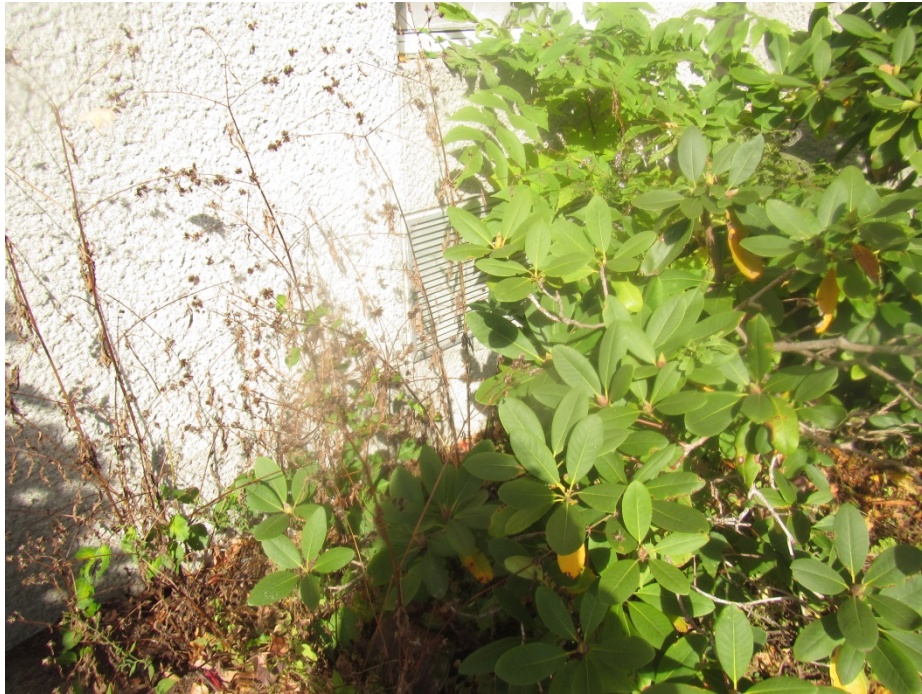
Picture 7

- Building gutter downspouts were found disconnected (Picture 21).
- Plants were found up against the foundation in several areas (Pictures 7 and 22). Plants hold moisture against the side of the building and roots can damage the foundation and lead to water infiltration. In addition, plants can be a source of pollen, mold and odors into the indoor air when they are close to intake vents as shown in Picture 7.

Supply vent for lower level unit ventilator, obstructed by plants

15. Ensure the gutter/downspout system is intact and directing water away from the building.
16. Remove plants away from the foundation, and particularly away from fresh air supply vents.

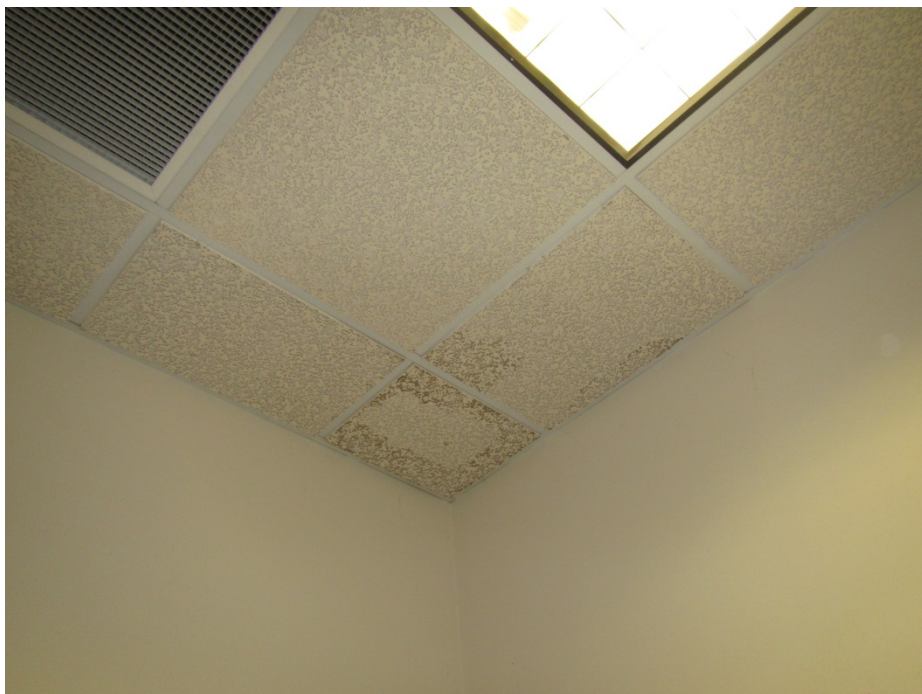
Picture 8

There were several concerns expressed by staff relating to water damage and odors in the building. Water-damaged ceiling tiles were observed in many areas (Pictures 8 and 9; Table 1), although the style of acoustic ceiling tile used in much of the building does not easily show water damage. A portion of the ceiling tile system on the main floor was removed and covered with plastic (Picture 10) reportedly due to chronic leaks from the roof and/or HVAC system. This portion of the ceiling was removed in August of 2018 along with other remediation efforts by a water damage remediation contractor (ServPro). According to documentation provided by ServPro, the area was contained using plastic sheeting, several bags of moistened ceiling tiles and insulation were removed, and the area was cleaned prior to removal of the containment barrier. It is not known when the ceiling tiles will be replaced.

Water-damaged ceiling tile

1. Operate the HVAC system when the building is occupied.
2. Continue with regular maintenance of the HVAC system including filter changes.
3. Develop a plan for addressing roof/HVAC leaks and replace ceiling tiles when leaks are addressed.

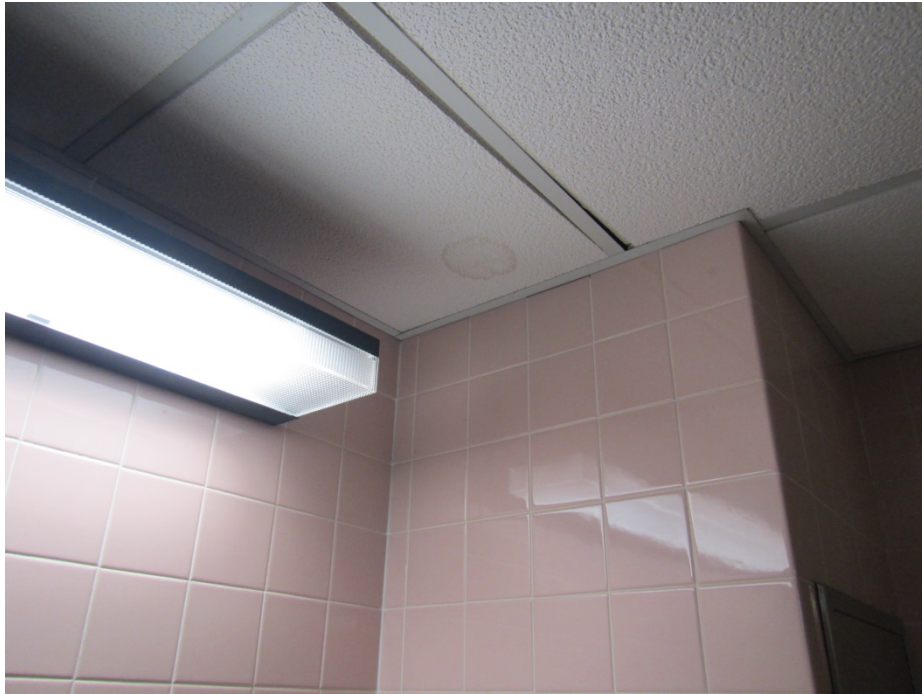
Picture 9

Water-damaged ceiling tile in the girls' bathroom on the lower level

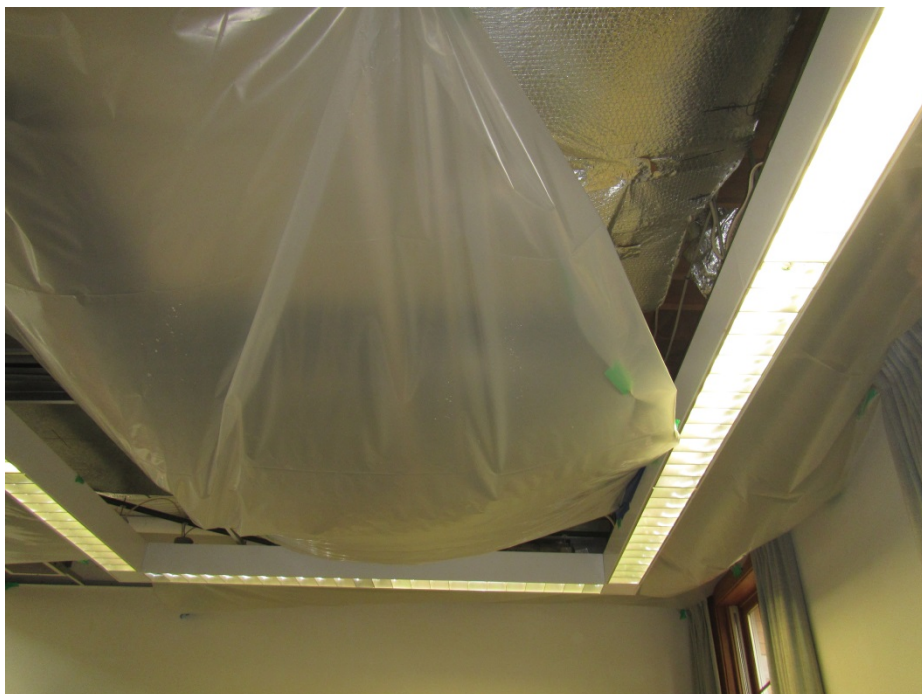
Picture 10

Removed ceiling tiles and plastic covering over part of the main floor

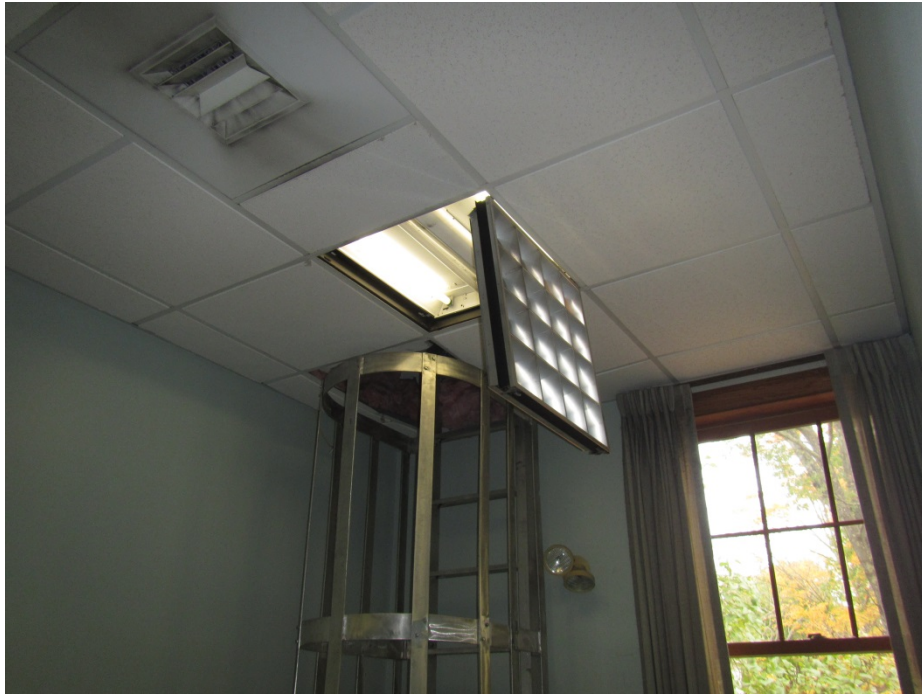
Picture 11

Building staff reported musty odors in the stairwell and Children’s Library main area. A slight musty odor was apparent in the stairwell. Several areas were investigated, and no odor was detected from the hatchway to the roof (Picture 11). Exposed insulation in the area shown was dry. An odor was present in the janitor’s closet (Picture 12) which opens onto this stairwell

Ladder for roof access in stairwell, note exposed insulation, curtains, and open light cover

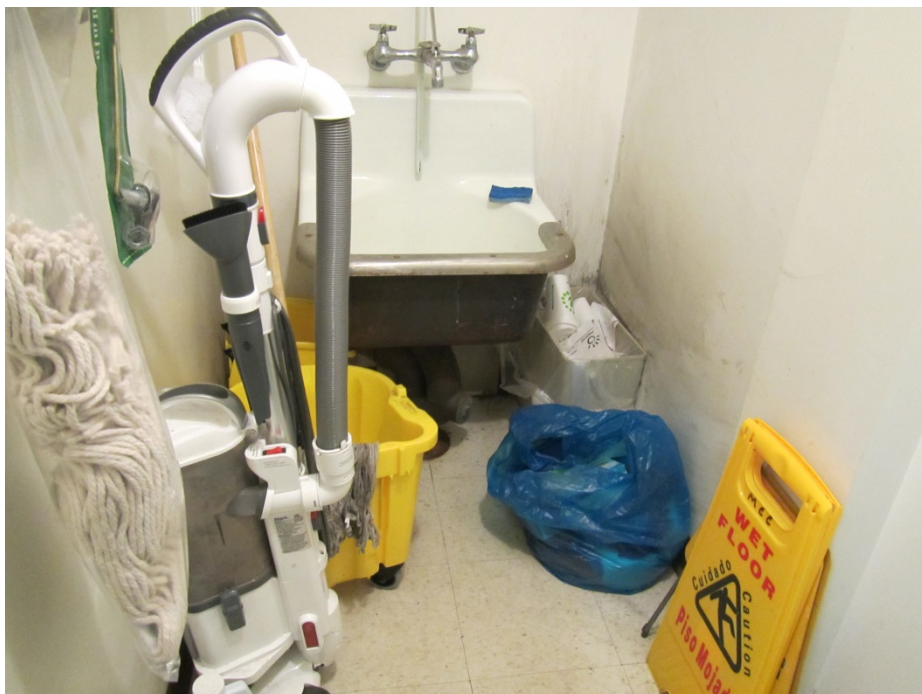
Picture 12

which has a janitorial sink as well as mops and mop buckets. Stagnant water from mops, a dry drain trap or debris-filled drain, and moistened walls from spills can all lead to musty/moldy odors. Note that the janitor's closet did not have an exhaust vent which would help in removing odors.

Janitorial closet with slop sink and mops

4. Ensure that drains, mops and mop buckets, and other materials in the janitor's closet are dry and odor-free. Clean or replace as needed.
5. Check the seal on the toilet in the girls' bathroom in the children's library for gaps leading to sewer odor. If this does not resolve the odor, consider contracting with a plumber to investigate if there are gaps in pipes or vents.

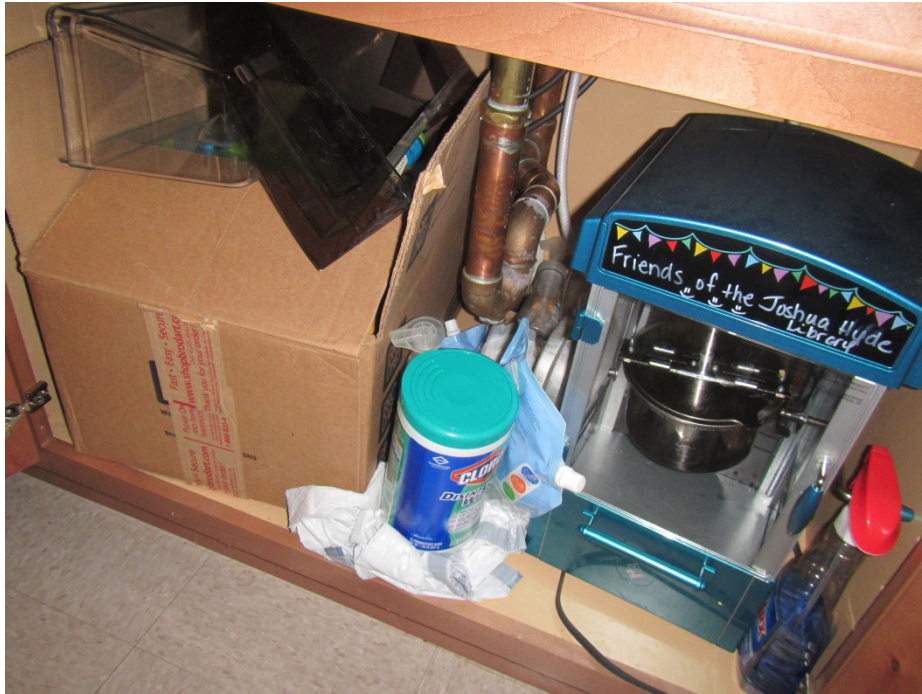
Picture 13

In the lowest level, there is a small kitchen with a sink, which had items, including porous items underneath it (Picture 13). There are also two storage rooms, one of which had a large sink in it which is currently not used (Picture 14). If this drain is not periodically filled with water, the trap will become dry and allow sewer odors and gas into the room.

Box and other porous items under the sink in the lower level

9. Avoid placing porous items under the sink in the lower level.
10. Ensure that doors between conditioned and unconditioned areas (outdoors, basement, attic) are well-fitted, weather-tight and kept closed.

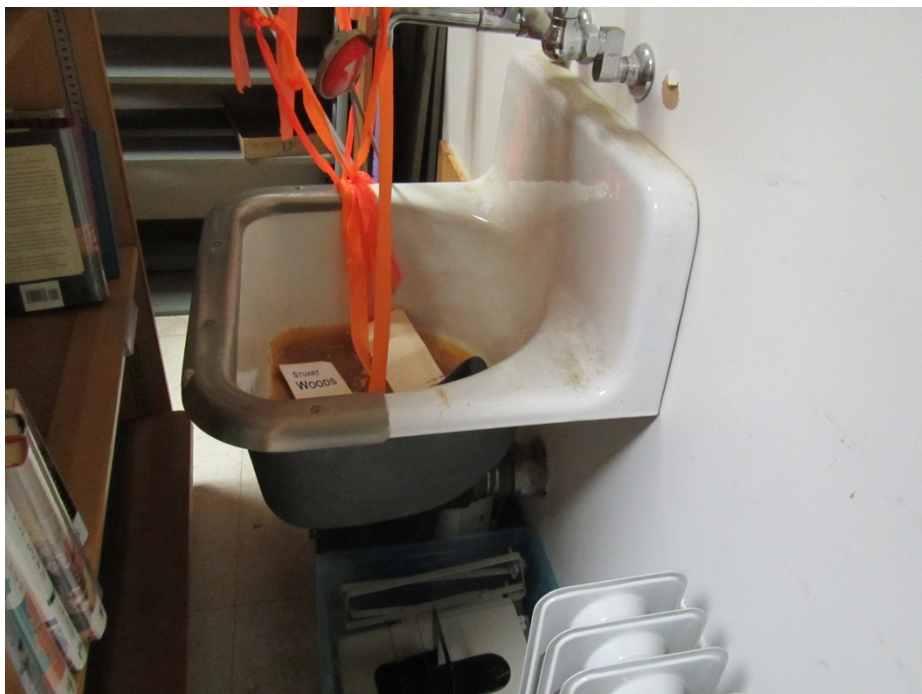
Picture 14

Disused large sink in lower level storage room

7. Consider removing carpeting in basement areas and near entrances and installing non-porous flooring materials (e.g., tile).
8. Ensure the janitorial sink on the lowest level is periodically filled with water. If this sink is no longer needed, consider having it properly removed and the plumbing cut and capped.

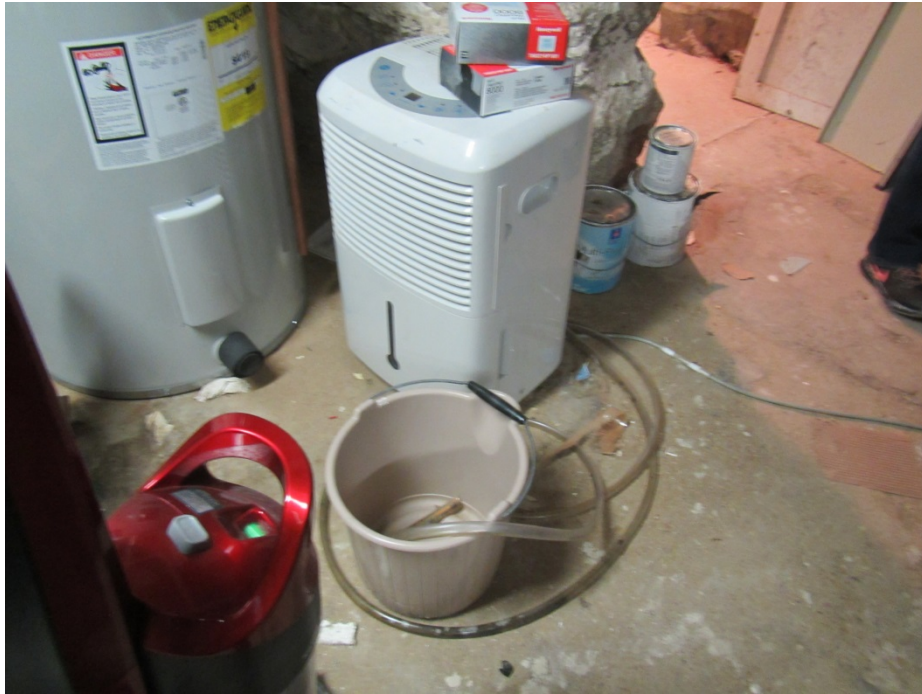
Picture 15

There is also an unfinished basement area right off the stairwell that has a concrete floor with brick and stone walls. The water heater and controls for the HVAC system are located in this area (Picture 15). This location has at least periodic humidity/moisture issues as shown by mold spots on wallboard used on the ceiling near the door to the stairwell (Picture 16). The wallboard should be replaced with a non-porous material. As shown in Picture 15, a dehumidifier is present but was not operating at the time of the assessment. Dehumidifiers can prevent moisture-related issues in basement areas, but they need to be maintained regularly, including emptying receptacles and cleaning, to prevent mold growth and odors.

Dehumidifier (not currently plugged in) and water heater in concrete-floored basement

11. Remove the mold-colonized wallboard from the ceiling in the basement (Picture 16).
12. If the dehumidifier in the basement is to be used, ensure it is properly maintained, including cleaning and drainage.

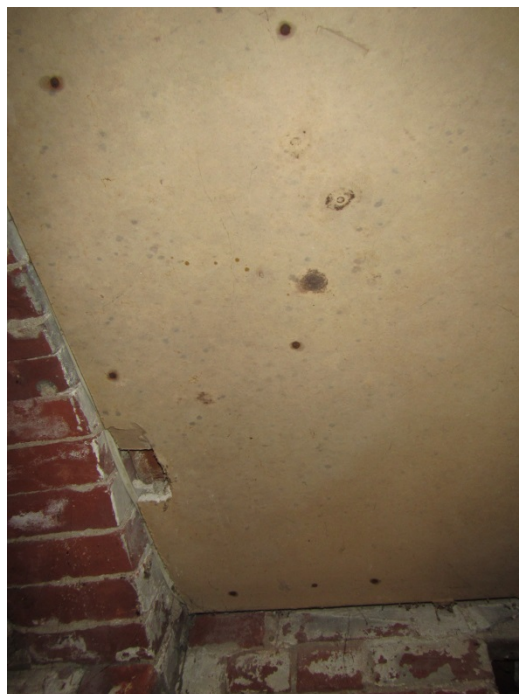
Picture 16

Mold-colonized wallboard on the ceiling of the basement

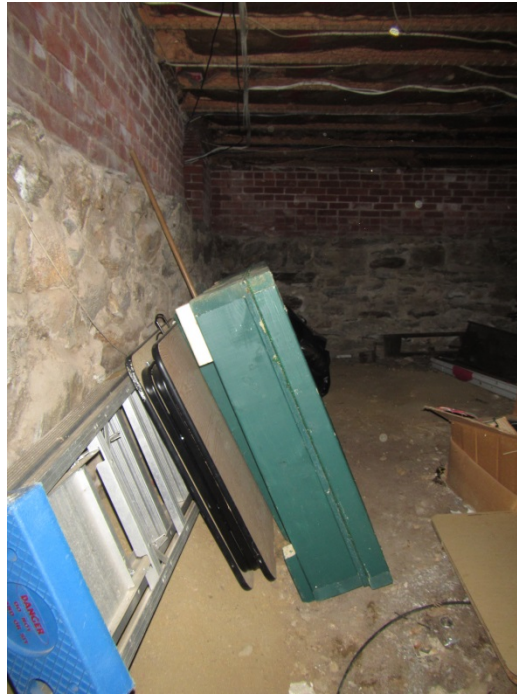
Picture 17

Unfinished basement

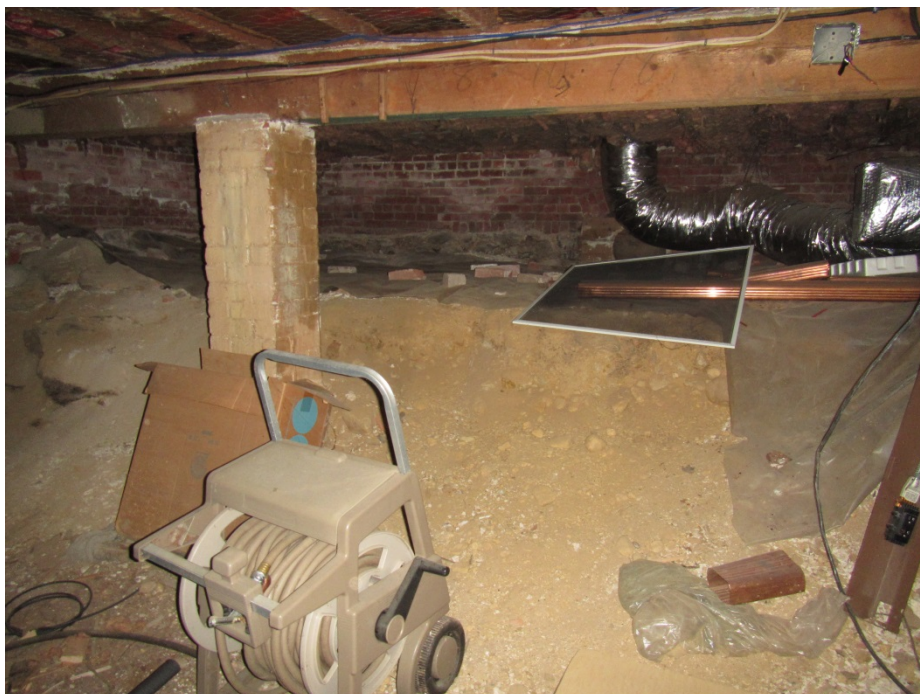
Picture 18

This area is used for storage and has items and surfaces with dust and debris on them, but no musty odors were detected. It is important that the door to this area from the hallway/stairwell be made as air-tight as possible to avoid moisture, odors, dust/debris and pests from migrating to occupied areas. Also note that within this basement area is a second door which leads to an unfinished basement area with a dirt floor and low ceiling (Pictures 17 and 18). While some ductwork and electrical service runs through this area, this space should generally not be used for

Items, ductwork, dirt floor in unfinished basement

14. Remove any stored items from the less finished basement and render the door between the two basement areas weather tight, including filling gaps between the door frame and wall with an appropriate sealant.

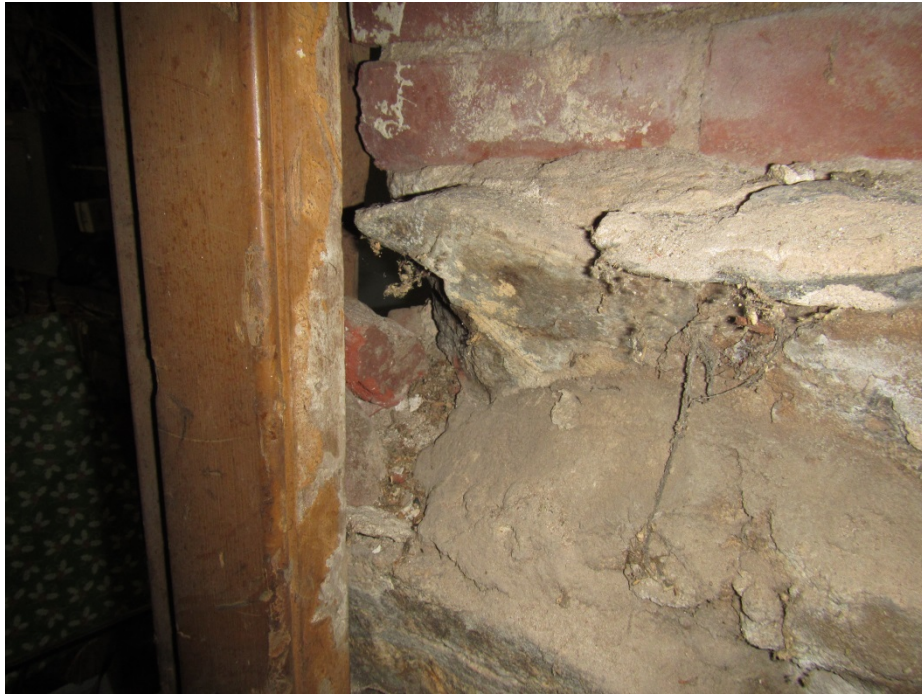
Picture 19

storage or other activities unless needed for maintenance. The door between the two basement areas is not air-tight, gaps exist between the door frame and wall (Picture 19), and electric wires run along the top of the door preventing it from closing completely (Picture 20). This door should also be rendered as air-tight as possible.

Gap between door frame and wall on door between basement areas

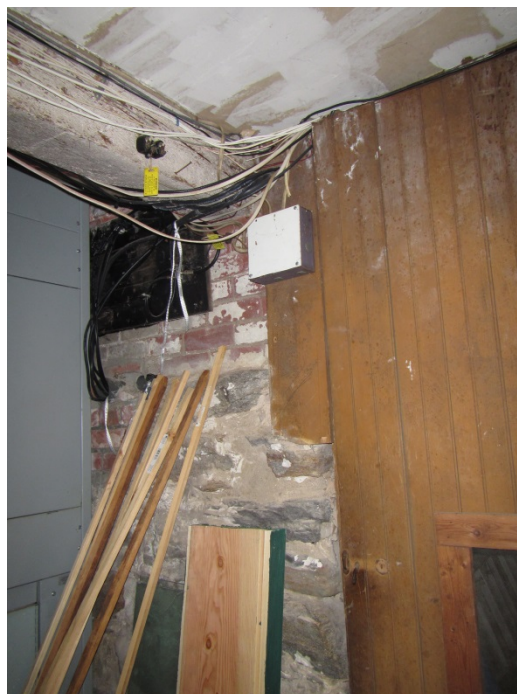
Picture 20

Wires preventing door from closing completely

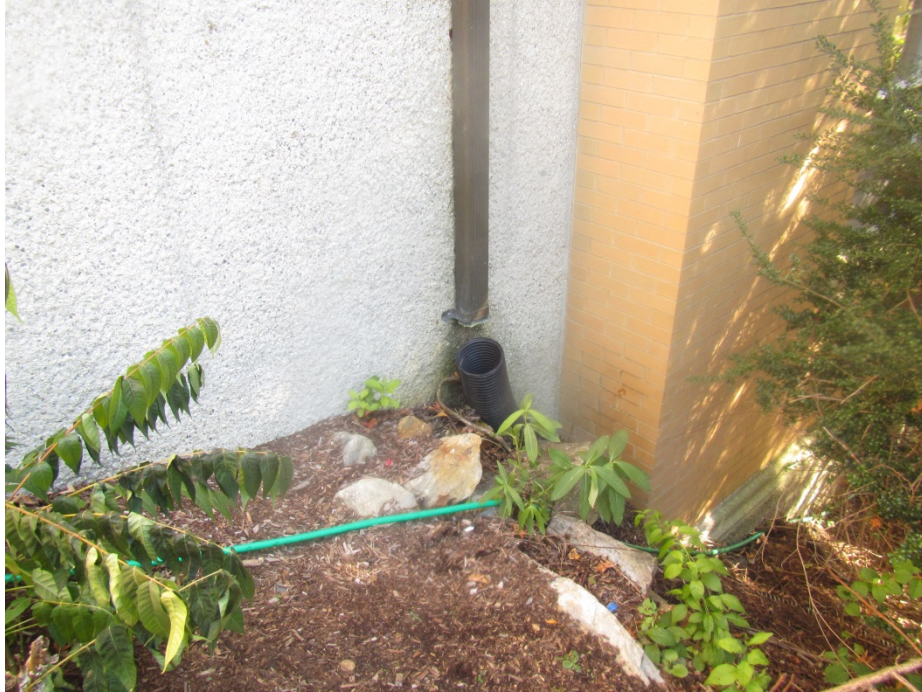
Picture 21

Disconnected downspout

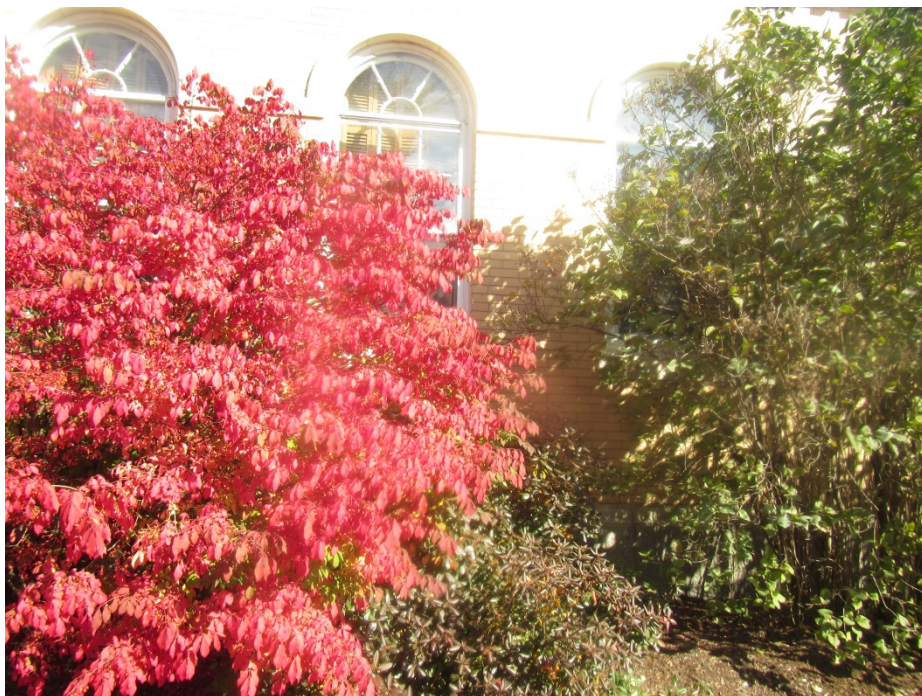
Picture 22

Plants against the side of the building

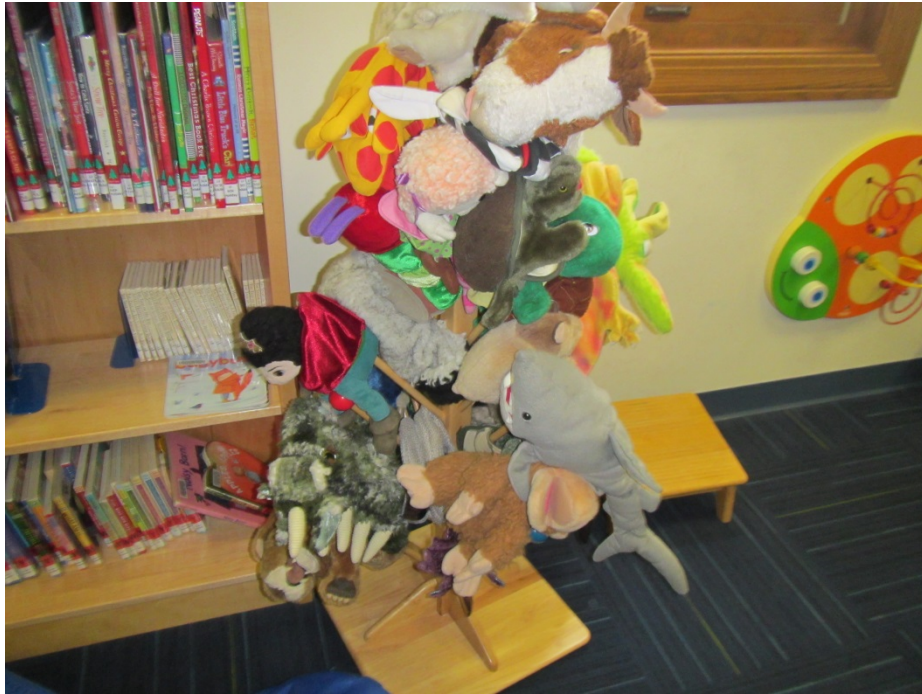
Picture 23

Upholstered furniture and plush toys are present in several areas (Picture 23; Table 1). Upholstered furniture, pillows and cushions are covered with fabric that comes in contact with human skin. This type of contact can leave oils, perspiration, hair and skin cells. Dust mites feed upon human skin cells and excrete waste products that contain allergens. In addition, if relative humidity levels increase above 60 percent, dust mites tend to proliferate (US EPA, 1992). In order to remove dust mites and other pollutants, frequent vacuuming of upholstered furniture is recommended (Berry, M.A., 1994). It is also recommended that upholstered furniture be professionally cleaned on an annual basis. If outdoor conditions or indoor activities (e.g., renovations) create an excessively dusty environment, cleaning frequency should be increased (every six months) (IICRC, 2000).

Plush toys

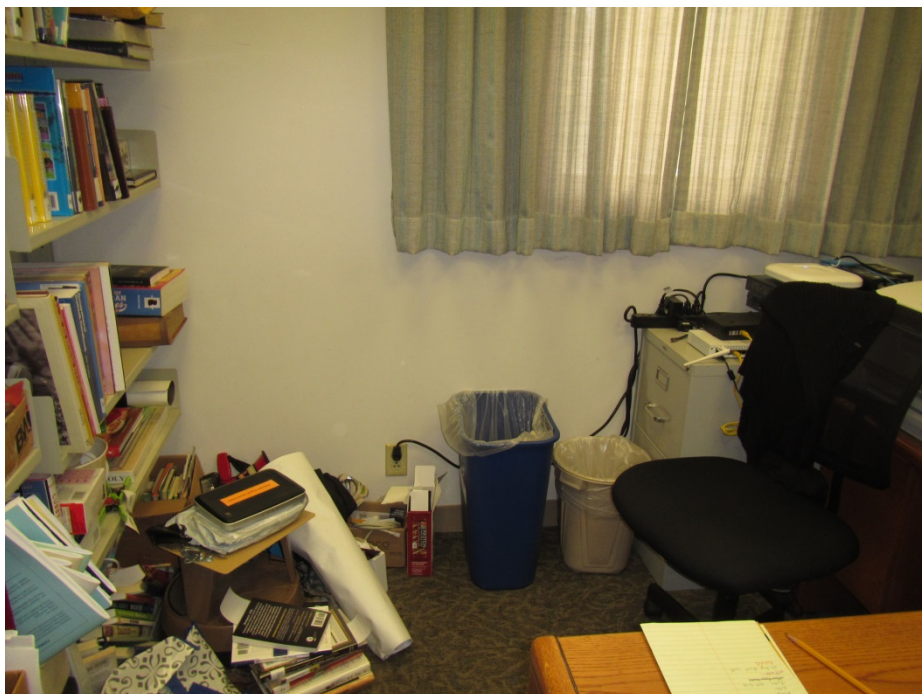
Picture 24

In some areas, there were items on the floor, against walls and on flat surfaces, which makes it difficult to clean (Picture 24). Items should be stored neatly and moved periodically for cleaning. Cloth curtains were in use for some of the tall windows, and the upper portions of these in particular appeared dusty. Curtains should be cleaned periodically to remove dust.

Items on the floor

17. Keep stored items off the floor and contained in an organized manner (e.g., shelves, cabinets or totes) to make them easier to clean. Non-porous stored items should be cleaned periodically using a high efficiency particulate arrestance (HEPA) filter-equipped vacuum cleaner followed by wet wiping to prevent the buildup of dusts that can become re-aerosolized or dampened and mold-colonized.
